**Flood Control Project Maintenance
Levee Inspections**
LMA District Cover Sheet
Spring 2018 Levee Inspection Results

Reclamation District No. 0307 Lisbon

Spring 2018 Levee Inspection Results

Waterway			Bank	Unit Miles
Unit No. 01 Sacramento River			Right	6.56
	Spring (March - May)	Summer (June - August)	(September - November) Fall	Winter (December - February)
Unit Maintenance Rating (Fall Only)				
Date of Inspection	3/6/2018 - 3/6/2018			
DWR Inspector	Dave Torres			
Accompanied By	Pete Dwyer RD 307

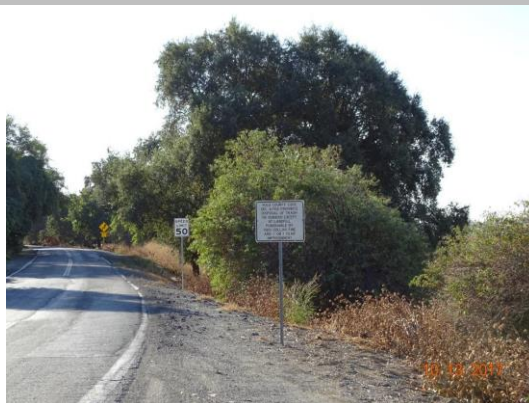
Photo 1 of 1 : SP_2018_RD0307_166_61_20180301_00035.jpg

LM Start	0.01	Rating **	U	Issue No.	61
LM End	0.22	Issue Type +	Ma	Location *	LS
Category	Earthen Levee			GPS Latitude/Longitude	
				Start	End
Item	Vegetation			38.479953 °	38.477806 °
				-121.549427 °	-121.546679 °
DWR ID	DWR_RD0307_01_f_2017_61				
Comment Code					
V2 : Remove the wild growth other than native grasses from the levee slopes.					
Inspector Comment

Landside vegetation should be reduced and maintained to allow inspection and access to slope and toe.

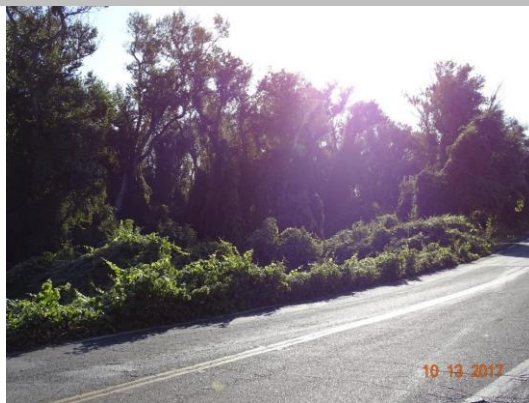
Photo 1 of 1 : SP_2018_RD0307_166_60_20180301_00034.jpg

LM Start	0.01	Rating **	U	Issue No.	60
LM End	0.23	Issue Type +	Ma	Location *	WS
Category	Earthen Levee			GPS Latitude/Longitude	
				Start	End
Item	Vegetation			38.479912 °	38.477725 °
				-121.549293 °	-121.546511 °
DWR ID	DWR_RD0307_01_f_2017_60				
Comment Code					
V2 : Remove the wild growth other than native grasses from the levee slopes.					
Inspector Comment

Waterside vegetation should be trimmed to 20 feet from crown to allow inspection.

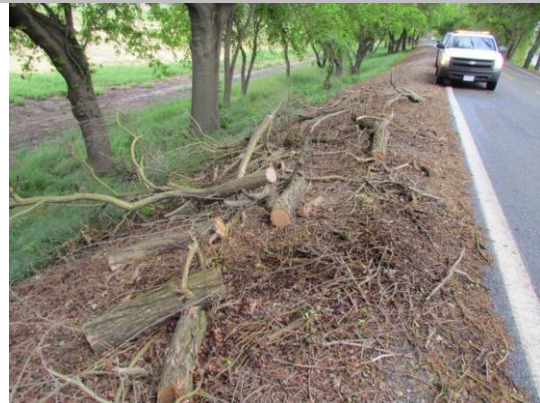
Photo 1 of 1 : SP_2018_RD0307_166_59_20180301_00033.jpg

LM Start	0.35	Rating **	M	Issue No.	59
LM End	0.35	Issue Type +	Ma	Location *	LS
Category	Earthen Levee			GPS Latitude/Longitude	
				Start	End
Item	Encroachments			38.476428 °	38.476428 °
				-121.544955 °	-121.544955 °
DWR ID	DWR_RD0307_01_s_2017_59				
Comment Code					
TR : Tree or limb					
Inspector Comment					
Remove the cut up fallen tree from the landside levee slope and shoulder.

RD 307 Landside slope looking downstream from levee mile 0.35.

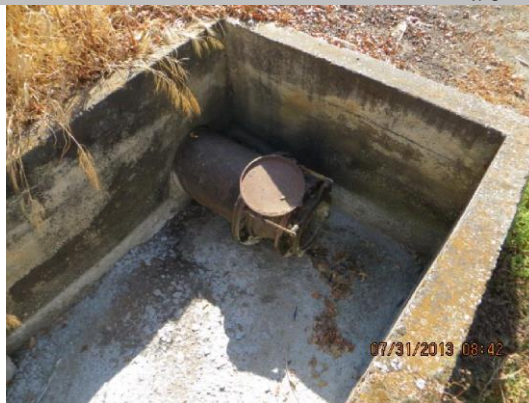
Photo 2 of 3 : UCIP_SP_2018_51632_28732.jpg

Comment Code						
Inspector Comment						
FS_ID:51632 DS_ID:21657 EP_NO: N/A Repair Type: Urgent Crossing Status: Found UCIP Comments: 12/07/2016 Same as last inspection. The bottom portion of the pipe has several holes through the wall. Recommend owner stop use of crossing. Owner will need to coordinate with CVFPB to comply with Title 23 requirements. (O. Magana - DWR UCIP)07/31/2013 Pipe heavily corroded and will likely need replacement if 15-inch pipe sleeved through it needs replacement. Annular space not grouted between two pipes. (W. Wylie - DWR UCIP) FIELD_STRUCT_DESC: 15-inch steel irrigation pipe through the levee, 16.7 feet below the crown. 15-inch pipe sleeved through an existing 20-inch pipe. 20-inch pipe first recorded in the 1964 USACE O&M Manual. Pump missing from abandoned steel pier located on the waterside (WS) toe. Walkway on the waterside (WS) from shoulder to pier missing or abandoned. Concrete U-shaped outlet with flap gate is located on the landside (LS) toe. Service pole located on the LS slope with anchor. [Additional Reference(s): DWR Levee Log, 1990. USACE Sacramento O&M Manual Unit 114, October 1964, (River Mile 48.53)]. FS Date: 12/7/2016

Pipe at outlet on LS toe.

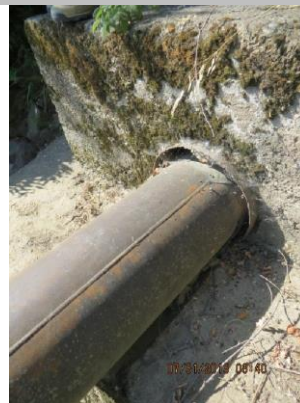
Photo 1 of 3 : UCIP_SP_2018_51444_28722.jpg

Comment Code					
Inspector Comment					
FS_ID:51444 DS_ID:21656 EP_NO: N/A Repair Type: Urgent Crossing Status: Found UCIP Comments: 12/07/2016 Same as last inspection. The bottom portion of the pipe has several holes through the wall. Recommend owner stop use of crossing. Owner will need to coordinate with CVFPB to comply with Title 23 requirements. (O. Magana - DWR UCIP)07/31/2013 Pipe heavily corroded at outlet on LS toe. Holes on bottom of pipe at outlet and internal circumference shows heavy exfoliation. Pipe failing internally. Recommend replacement or video inspection before continuing use. (W. Wylie - DWR UCIP) FIELD_STRUCT_DESC: *DUPLICATE--DELETE* 1 of 2: 15-inch steel irrigation pipe sleeved through 21-inch steel conduit, through the levee 16.7 feet below crown. Slant pump, gate valve, concrete headwall, electrical control pane, and abandoned pier on WS slope. Concrete U-shaped outlet with flap gate on LS toe. Service pole on the landward slope with anchor. [Additional Reference(s): DWR Levee Log, 1990]. FS Date: 12/7/2016

15-inch pipe sleeved through 21-inch pipe on WS slope at headwall.

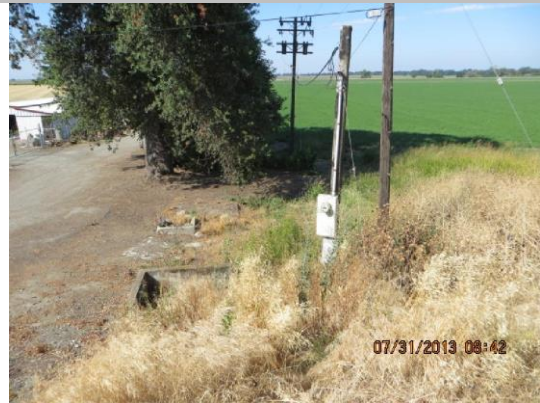
Photo 3 of 3 : UCIP_SP_2018_51444_28720.jpg

Comment Code						
Inspector Comment						
FS_ID:51444						
DS_ID:21656						
EP_NO: N/A						
Repair Type: Urgent						
Crossing Status: Found						
UCIP Comments: 12/07/2016 Same as last inspection. The bottom portion of the pipe has several holes through the wall. Recommend owner stop use of crossing. Owner will need to coordinate with CVFPB to comply with Title 23 requirements. (O. Magana - DWR UCIP)07/31/2013 Pipe heavily corroded at outlet on LS toe. Holes on bottom of pipe at outlet and internal circumference shows heavy exfoliation. Pipe failing internally. Recommend replacement or video inspection before continuing use. (W. Wylie - DWR UCIP)						
FIELD_STRUCT_DESC: *DUPLICATE--DELETE* 1 of 2: 15-inch steel irrigation pipe sleeved through 21-inch steel conduit, through the levee 16.7 feet below crown. Slant pump, gate valve, concrete headwall, electrical control pane, and abandoned pier on WS slope. Concrete U-shaped outlet with flap gate on LS toe. Service pole on the landward slope with anchor. [Additional Reference(s): DWR Levee Log, 1990].

Concrete U-shaped outlet, JP, and meter on LS toe.

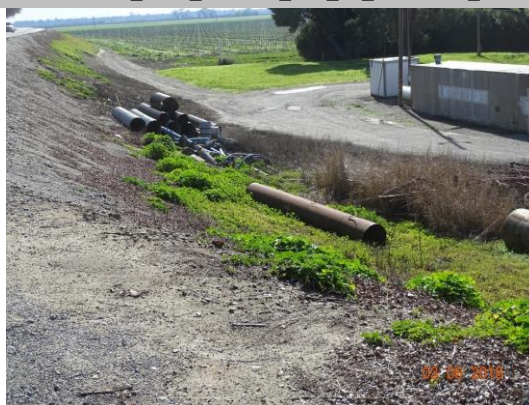
Photo 1 of 1 : SP_2018_RD0307_166_48_20180308_00140.jpg

LM Start	0.58	Rating **	M	Issue No.	48
LM End	0.58	Issue Type +	En	Location *	LS
Category	Earthen Levee			GPS Latitude/Longitude	
				Start	End
Item	Encroachments			38.474543 °	38.474543 °
				-121.541419 °	-121.541419 °
DWR ID	DWR_RD0307_01_s_2018_48				
Comment Code					
EQ : Equipment					
Inspector Comment					
Pipes stored at landside toe.

Encroachment pipes at landside toe looking southeast

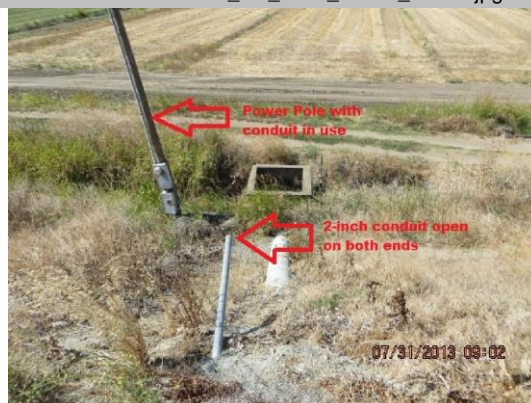
Photo 1 of 3 : UCIP_SP_2018_17103_29202.jpg

LM Start	0.93	Rating **	M	Issue No.	131
LM End	0.93	Issue Type +	En	Location *	
Category	Supplemental			GPS Latitude/Longitude	
				Start	End
Item	DWR UCIP Field Study			38.472872 °	38.472872 °
				-121.535542 °	-121.535542 °
DWR ID					
Comment Code					
Inspector Comment					
FS_ID:17103 DS_ID:24014 EP_NO: 18229 Repair Type: Non-Urgent Crossing Status: Found UCIP Comments: Pipe open on both ends. Need to install caps. FIELD_STRUCT_DESC: 2 of 2: 2-inch galvanized iron electrical conduit through the levee, 2 feet below the crown. (Permit No. 18229, 2007 - Albert Martinelli). FS Date: 7/31/2013

Conduit visible 2-feet below the crown on the LS shoulder.

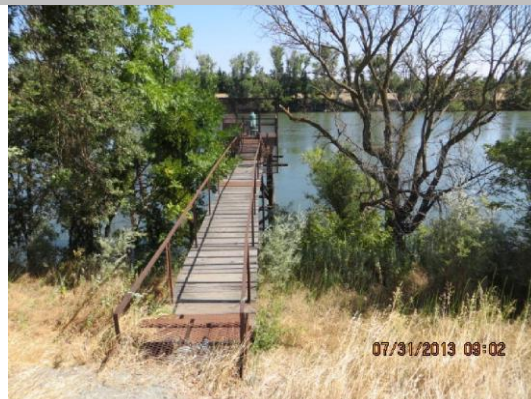
Photo 2 of 3 : UCIP_SP_2018_17103_29201.jpg

Conduit visible under first step of walkway to pump on WS shoulder.

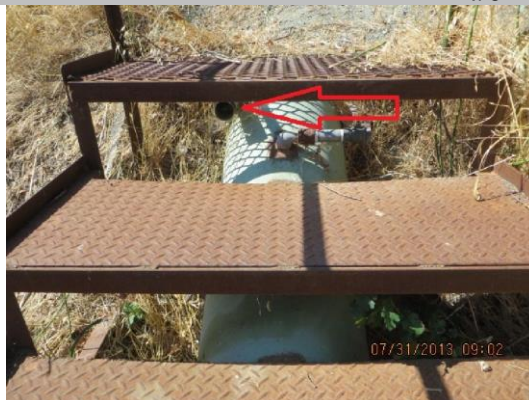
Photo 3 of 3 : UCIP_SP_2018_17103_29200.jpg

LM Start	0.93	Rating **	M	Issue No.	131 (cont)
LM End	0.93	Issue Type +	En	Location *	
Category	Supplemental			GPS Latitude/Longitude	
				Start	End
Item	DWR UCIP Field Study			38.472872 °	38.472872 °
				-121.535542 °	-121.535542 °
DWR ID					
Comment Code					
Inspector Comment					
FS_ID:17103 DS_ID:24014 EP_NO: 18229 Repair Type: Non-Urgent Crossing Status: Found UCIP Comments: Pipe open on both ends. Need to install caps. FIELD_STRUCT_DESC: 2 of 2: 2-inch galvanized iron electrical conduit through the levee, 2 feet below the crown. (Permit No. 18229, 2007 - Albert Martinelli). FS Date: 7/31/2013

Conduit visible under first step of walkway to pump on WS shoulder.

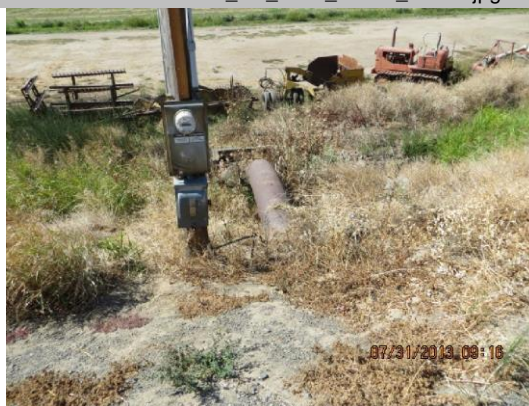
Photo 1 of 3 : UCIP_SP_2018_16764_28764.jpg

Comment Code					
Inspector Comment					
FS_ID:16764 DS_ID:21659 EP_NO: 8012 Repair Type: Non-Urgent Crossing Status: Found UCIP Comments: Pipe rusted through at outlet on LS of shutoff valve. This may be good indicator or corrosion throughout pipe. This is a good candidate for video inspection. FIELD_STRUCT_DESC: 1 of 2: 20-inch steel irrigation pipe through the levee, 7.4 feet below the crown. Walkway from the waterside (WS) shoulder to pump on pile structure in stream. Distribution box and gate valve at the landside (LS) toe. Service pole on the LS. (Permit No. 8012, 1972 - Eula Glide Elliott). [Additional Reference(s): DWR Levee Log, 1990. USACE Sacramento O&M Manual 114, April 1959, (RM 48.53)]. FS Date: 7/31/2013

Pipe and JP/meter on LS slope.

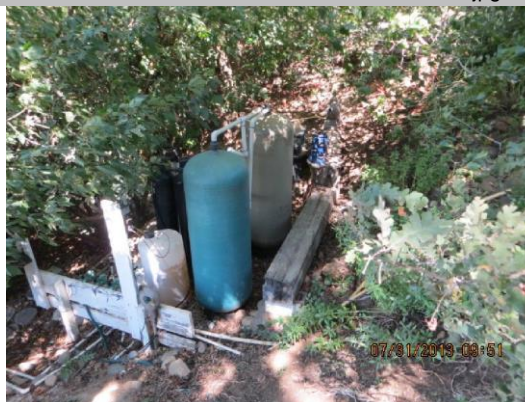
Photo 1 of 3 : UCIP_SP_2018_17106_29210.jpg

LM Start	1.62	Rating **	M	Issue No.	135
LM End	1.62	Issue Type +	En	Location *	
Category	Supplemental			GPS Latitude/Longitude	
				Start	End
Item	DWR UCIP Field Study			38.473129 °	38.473129 °
				-121.522717 °	-121.522717 °
DWR ID					
Comment Code					
Inspector Comment					
FS_ID:17106 DS_ID:24016 EP_NO: N/A Repair Type: Non-Urgent Crossing Status: Found UCIP Comments: No permit identified for this crossing. FIELD_STRUCT_DESC: 1 of 2: 1.5-inch polyvinyl chloride (PVC) irrigation pipe through the levee, 2 feet below the crown. Metal walkway and pier on the waterside (WS) slope. Possible pump, filter, and tanks on the landside (LS) slope. FS Date: 7/31/2013

Possible pump and filter plant on LS slope.

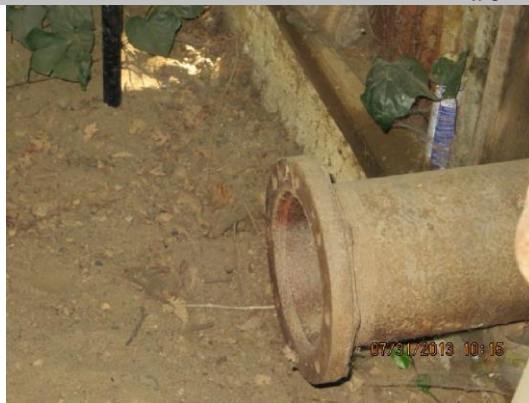
Photo 1 of 2 : UCIP_SP_2018_16805_28806.jpg

Remnants of abandoned pipe visible in pumphouse on LS toe.

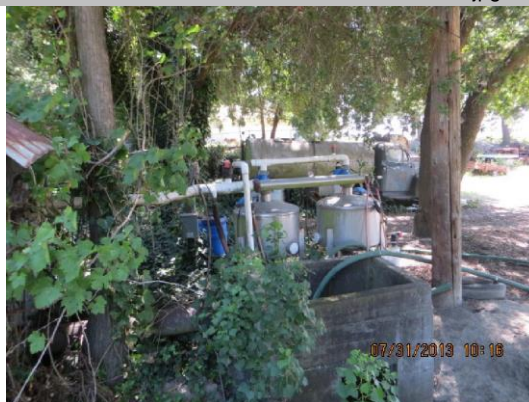
Photo 2 of 2 : UCIP_SP_2018_16805_28805.jpg

Concrete distribution box at LS toe.

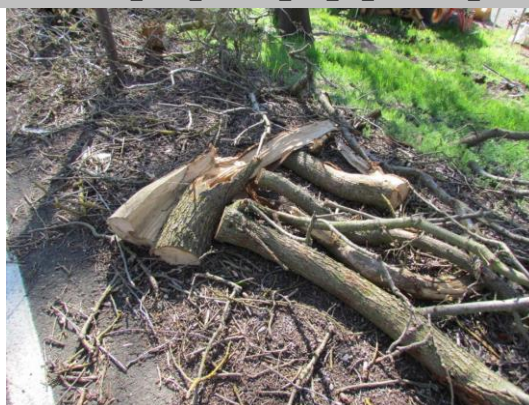
Photo 1 of 3 : SP_2018_RD0307_166_73_20180301_00038.jpg

LM Start	1.86	Rating **	U	Issue No.	73
LM End	1.86	Issue Type +	Ma	Location *	LS
Category	Earthen Levee			GPS Latitude/Longitude	
				Start	End
Item	Encroachments			38.473182 °	38.473182 °
				-121.518280 °	-121.518280 °
DWR ID	DWR_RD0307_01_s_2016_73				
Comment Code					
TR : Tree or limb					
Inspector Comment					
Remove the cut up oak tree from both ls/ws slops the levee section. No change 4-17.

Looking downstream from levee mile 1.86 cut up fallen tree on shoulder.

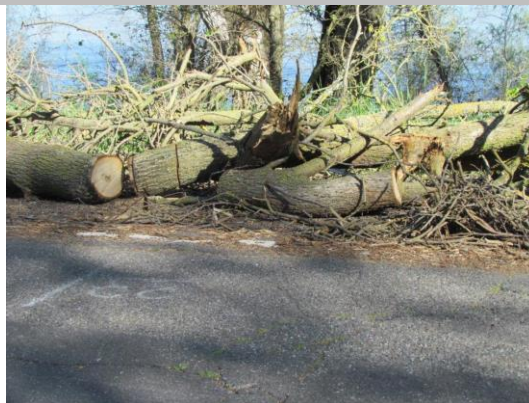
Photo 3 of 3 : SP_2018_RD0307_166_73_20180301_00040.jpg

LM Start	1.86	Rating **	U	Issue No.	73 (cont)	
LM End	1.86	Issue Type +	Ma	Location *	LS	
Category	Earthen Levee			GPS Latitude/Longitude		
				Start		End
Item	Encroachments			38.473182 °		38.473182 °
				-121.518280 °		-121.518280 °
DWR ID	DWR_RD0307_01_s_2016_73					
Comment Code						
TR : Tree or limb						
Inspector Comment						
Remove the cut up oak tree from both ls/ws slops the levee section. No change 4-17.

Waterside shoulder levee mile 1.86 more of the cut up oak.

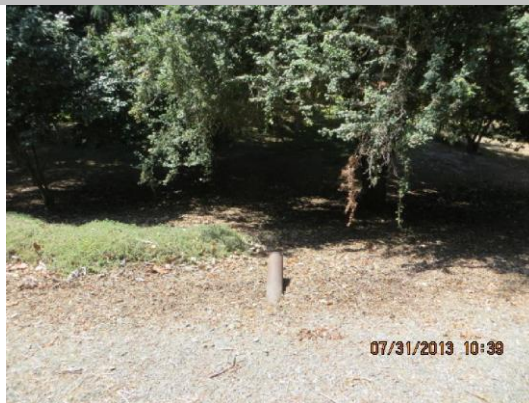
Photo 2 of 3 : UCIP_SP_2018_22709_38411.jpg

Pipe visible on LS shoulder.

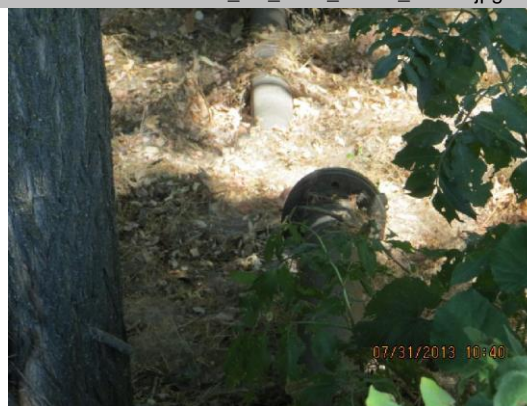
Photo 3 of 3 : UCIP_SP_2018_22709_38410.jpg

LM Start	2.21	Rating **	M	Issue No.	137 (cont)	
LM End	2.21	Issue Type +	En	Location *		
Category	Supplemental			GPS Latitude/Longitude		
				Start	End	
Item	DWR UCIP Field Study			38.472238 °	38.472238 °	
				-121.512032 °	-121.512032 °	
DWR ID						
Comment Code						
Inspector Comment						
FS_ID:22709 DS_ID:21665 EP_NO: N/A Repair Type: Non-Urgent Crossing Status: Found UCIP Comments: Pipe abandoned and should be done so properly. FIELD_STRUCT_DESC: 5-inch steel irrigation pipe through the levee, 2 feet below the crown. Pipe open on both ends. [Additional Reference(s): DWR Levee Log, 1990. USACE Sacramento O&M Manual 114, April 1959, (RM 47.38) (6-inch pipe listed)]. FS Date: 7/31/2013

Pipe visible on WS slope.

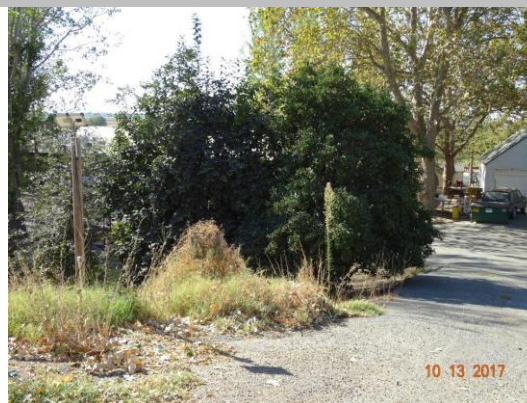
Photo 1 of 1 : SP_2018_RD0307_166_92_20180301_00046.jpg

LM Start	2.22	Rating **	M	Issue No.	92
LM End	2.22	Issue Type +	En	Location *	LS
Category	Earthen Levee			GPS Latitude/Longitude	
				Start	End
Item	Encroachments			38.472155 °	38.472155 °
				-121.511764 °	-121.511764 °
DWR ID	DWR_RD0307_01_f_2017_92				
Comment Code					
TR : Tree or limb					
Inspector Comment					
Remove fruit trees on levee slope.

Remove fruit trees on levee slope.

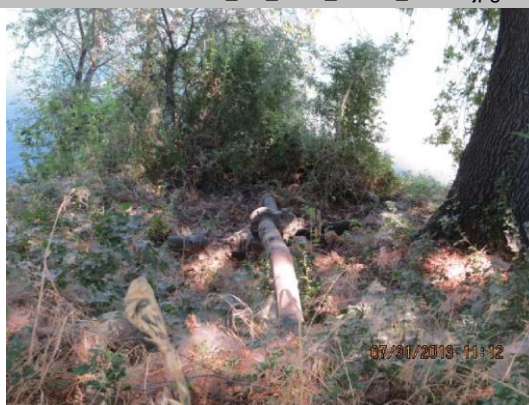
Photo 1 of 3 : UCIP_SP_2018_40794_28823.jpg

LM Start	2.42	Rating **	M	Issue No.	138
LM End	2.42	Issue Type +	En	Location *	
Category	Supplemental			GPS Latitude/Longitude	
				Start	End
Item	DWR UCIP Field Study			38.471093 °	38.471093 °
				-121.508429 °	-121.508429 °
DWR ID					
Comment Code					
Inspector Comment					
FS_ID:40794 DS_ID:21667 EP_NO: N/A Repair Type: Non-Urgent Crossing Status: Found UCIP Comments: Pipe appears abandoned and if so should be done so properly. FIELD_STRUCT_DESC: 6-inch steel irrigation pipe through the levee, 3 feet below the crown. Pump and gate valve on the waterside (WS) slope. 36-inch concrete standpipe on the landside (LS) toe. [Additional Reference(s): DWR Levee Log, 1990. USACE Sacramento O&M Manual 114, April 1959, (RM 47.17)]. FS Date: 7/31/2013

Pump and gate valve on WS slope.

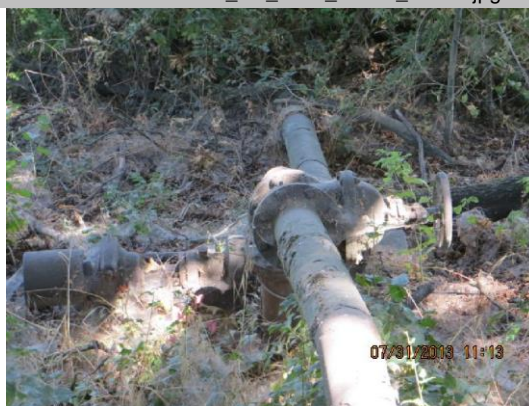
Photo 2 of 3 : UCIP_SP_2018_40794_28822.jpg

LM Start	2.42	Rating **	M	Issue No.	138 (cont)	
LM End	2.42	Issue Type +	En	Location *		
Category	Supplemental			GPS Latitude/Longitude		
				Start		End
Item	DWR UCIP Field Study			38.471093 °		38.471093 °
				-121.508429 °		-121.508429 °
DWR ID						
Comment Code						
Inspector Comment						
FS_ID:40794						
DS_ID:21667						
EP_NO: N/A						
Repair Type: Non-Urgent						
Crossing Status: Found						
UCIP Comments: Pipe appears abandoned and if so should be done so properly.						
FIELD_STRUCT_DESC: 6-inch steel irrigation pipe through the levee, 3 feet below the crown. Pump and gate valve on the waterside (WS) slope. 36-inch concrete standpipe on the landside (LS) toe. [Additional Reference(s): DWR Levee Log, 1990. USACE Sacramento O&M Manual 114, April 1959, (RM 47.17)].						
FS Date: 7/31/2013

Pump and gate valve on WS slope.

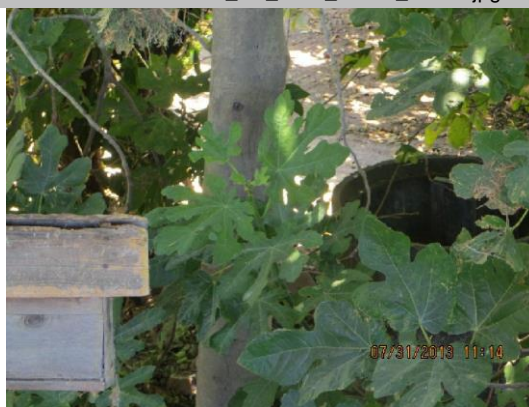
Photo 3 of 3 : UCIP_SP_2018_40794_28821.jpg

36-inch concrete standpipe on LS toe.

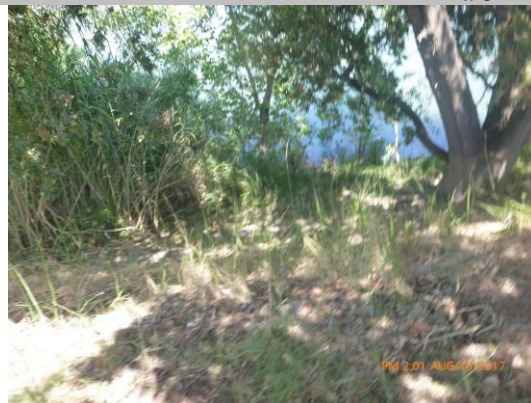
Photo 1 of 3 : LEVAL_SP_2018_500_4167.jpg

LM Start	2.47	Rating **	M	Issue No.	49
LM End	2.53	Issue Type +	Ma	Location *	
Category	Supplemental			GPS Latitude/Longitude	
				Start	End
Item	2017 Storm Damage			38.470583 °	38.470052 °
				-121.507658 °	-121.506902 °
DWR ID	DWR_RD0307_01_f _ 2017_49				
Comment Code					
Inspector Comment					
Levee Evaluation Comments					
Description:Slope protection repairs are needed along the waterside slope due to erosion and riprap displacement from high water. Based upon levee inspections, it was determined the waterside levee slope is eroding, deteriorating, and degrading. The eroded levee sections need to be restored back to design standards to prevent further deterioration and damage.					
Site ID No:500					
Site Designation:LMA-406					
Repair Type: Erosion					
Rating:Area of Concern					
Field Date:8/15/2017					
Notes:

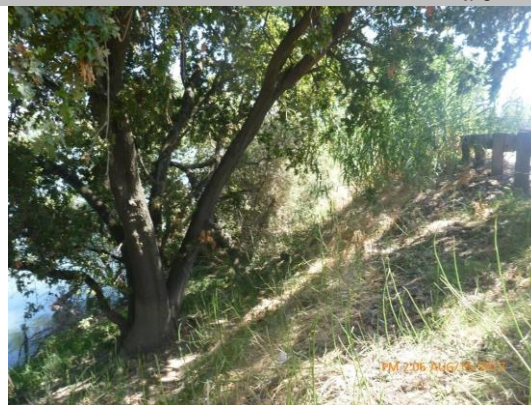
Photo 2 of 3 : LEVAL_SP_2018_500_4168.jpg

LM Start	2.47	Rating **	M	Issue No.	49 (cont)
LM End	2.53	Issue Type +	Ma	Location *

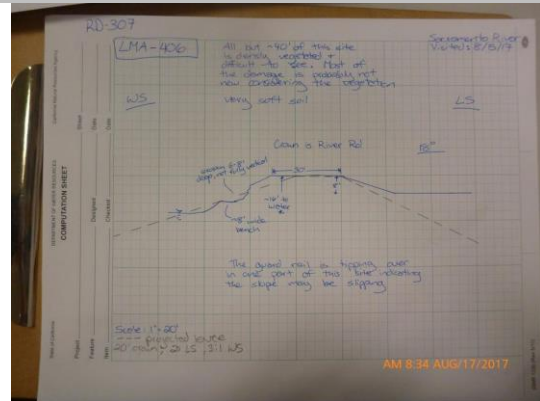
Photo 3 of 3 : LEVAL_SP_2018_500_4226.jpg

LM Start	2.47	Rating **	M	Issue No.	49 (cont)
LM End	2.53	Issue Type +	Ma	Location *	
Category	Supplemental		GPS Latitude/Longitude		
			Start	End	
Item	2017 Storm Damage		38.470583 °	38.470052 °	
			-121.507658 °	-121.506902 °	
DWR ID	DWR_RD0307_01_f_2017_49				
Comment Code					
Inspector Comment					
<p>Levee Evaluation Comments</p> <p>Description: Slope protection repairs are needed along the waterside slope due to erosion and riprap displacement from high water. Based upon levee inspections, it was determined the waterside levee slope is eroding, deteriorating, and degrading. The eroded levee sections need to be restored back to design standards to prevent further deterioration and damage.</p> <p>Site ID No: 500</p> <p>Site Designation: LMA-406</p> <p>Repair Type: Erosion</p> <p>Rating: Area of Concern</p> <p>Field Date: 8/15/2017</p> <p>Notes:</p>

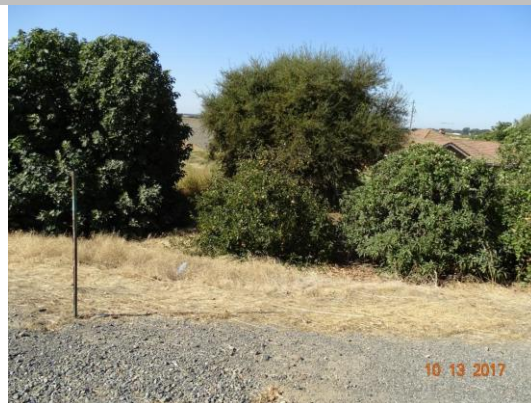
Photo 1 of 1 : SP_2018_RD0307_166_98_20180301_00051.jpg

LM Start	2.64	Rating **	M	Issue No.	98
LM End	2.64	Issue Type +	En	Location *	LS
Category	Earthen Levee			GPS Latitude/Longitude	
				Start	End
Item	Encroachments			38.468547 °	38.468547 °
				-121.506027 °	-121.506027 °
DWR ID	DWR_RD0307_01_f_2017_98				
Comment Code					
TR : Tree or limb					
Inspector Comment					
Remove fruit trees.

Remove fruit trees.

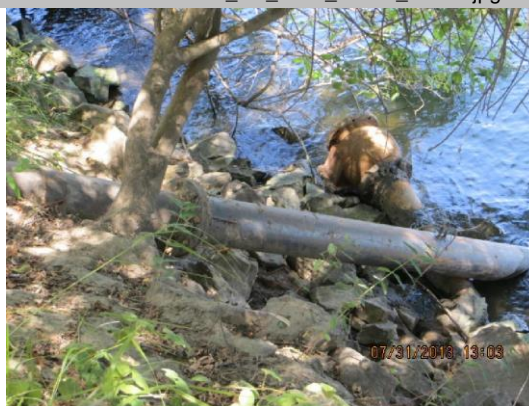
Photo 2 of 2 : UCIP_SP_2018_16843_28880.jpg

LM Start	3.44	Rating **	M	Issue No.	140 (cont)	
LM End	3.44	Issue Type +	En	Location *		
Category	Supplemental			GPS Latitude/Longitude		
				Start	End	
Item	DWR UCIP Field Study			38.457182 °	38.457182 °	
				-121.503847 °	-121.503847 °	
DWR ID						
Comment Code						
Inspector Comment						
FS_ID:16843 DS_ID:21677 EP_NO: N/A Repair Type: Non-Urgent Crossing Status: Found UCIP Comments: No access to pumphouse as fence is within 10-feet of toe. FIELD_STRUCT_DESC: 8-inch steel irrigation pipe through the levee, 11.8 feet below the crown. Pump house on the landside (LS) toe. 48-inch-diameter concrete standpipe just off the LS toe. [Additional Reference(s): DWR Levee Log, 1990. USACE Sacramento O&M Manual 114, April 1959, (RM 46.14)]. FS Date: 7/31/2013

Pipe visible on WS toe.

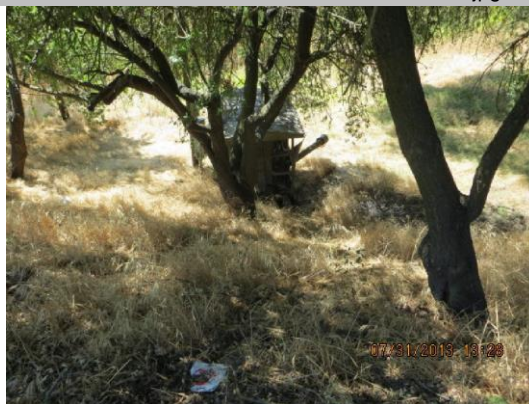
Photo 2 of 3 : UCIP_SP_2018_16923_28977.jpg

LM Start	3.60	Rating **	M	Issue No.	141
LM End	3.60	Issue Type +	En	Location *	
Category	Supplemental			GPS Latitude/Longitude	
				Start	End
Item	DWR UCIP Field Study			38.454939 °	38.454939 °
				-121.503146 °	-121.503146 °
DWR ID					
Comment Code					
Inspector Comment					
FS_ID:16923 DS_ID:21679 EP_NO: N/A Repair Type: Non-Urgent Crossing Status: Found UCIP Comments: Gate valve does not function on WS slope. Pipe and pump appear to be abandoned and should be done so properly. FIELD_STRUCT_DESC: 7-inch steel irrigation pipe through the levee, 14.7 feet below the crown. Pump in pump house on the landside (LS) toe. Gate valve on the waterside (WS) slope and at pump house on the LS toe. Air vent on pipe at the WS toe near the waterline. [Additional Reference(s): DWR Levee Log, 1990. USACE Sacramento O&M Manual 114, April 1959, (RM 45.98)]. FS Date: 7/31/2013

Pumphouse on LS toe.

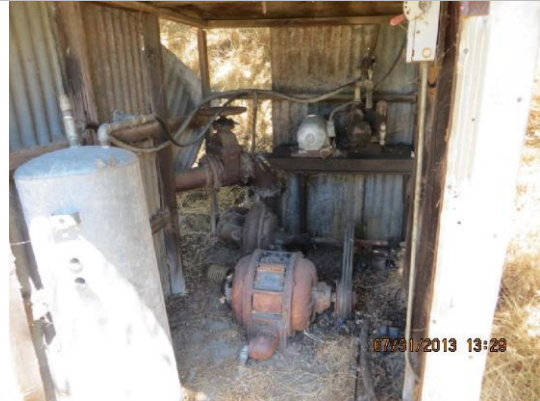
Photo 3 of 3 : UCIP_SP_2018_16923_28976.jpg

LM Start	3.60	Rating **	M	Issue No.	141 (cont)	
LM End	3.60	Issue Type +	En	Location *		
Category	Supplemental			GPS Latitude/Longitude		
				Start	End	
Item	DWR UCIP Field Study			38.454939 °	38.454939 °	
				-121.503146 °	-121.503146 °	
DWR ID						
Comment Code						
Inspector Comment						
FS_ID:16923 DS_ID:21679 EP_NO: N/A Repair Type: Non-Urgent Crossing Status: Found UCIP Comments: Gate valve does not function on WS slope. Pipe and pump appear to be abandoned and should be done so properly. FIELD_STRUCT_DESC: 7-inch steel irrigation pipe through the levee, 14.7 feet below the crown. Pump in pump house on the landside (LS) toe. Gate valve on the waterside (WS) slope and at pump house on the LS toe. Air vent on pipe at the WS toe near the waterline. [Additional Reference(s): DWR Levee Log, 1990. USACE Sacramento O&M Manual 114, April 1959, (RM 45.98)]. FS Date: 7/31/2013

Gate valve and pump in pumphouse on LS toe.

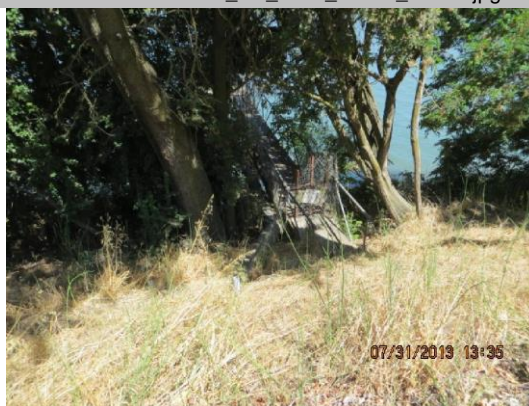
Photo 1 of 3 : UCIP_SP_2018_16924_28982.jpg

Comment Code					
Inspector Comment					
FS_ID:16924 DS_ID:21680 EP_NO: 8030 Repair Type: Non-Urgent Crossing Status: Found UCIP Comments: Pipe not visible on LS slope or toe due to excessive vegetation. Vegetation should be cleared from pipe. FIELD_STRUCT_DESC: 1 of 2: 12-inch steel irrigation pipe through the levee, 6 feet below the crown. Walkway on the waterside (WS) slope to a pump on a pile structure in the stream. Joint pole (JP) and meter on the landside (LS) toe. Pipe appears to cross the levee at an angle. (Permit No. 8030, 1972 - Robert and Hazel Kirkland). [Additional Reference(s): DWR Levee Log, 1990. USACE Sacramento O&M Manual 114, April 1959, (RM 45.92)]. FS Date: 7/31/2013

Pipe and walkway visible on WS slope.

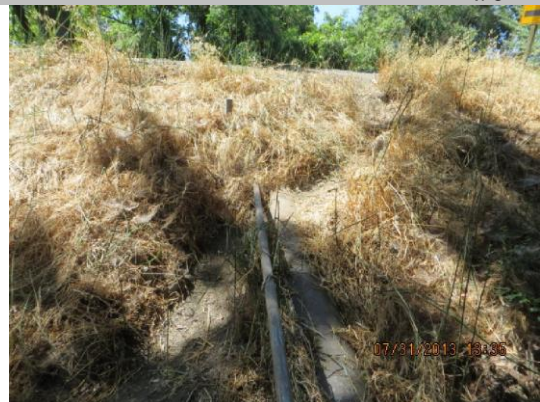
Photo 1 of 2 : UCIP_SP_2018_16925_28984.jpg

LM Start	3.66	Rating **	M	Issue No.	143
LM End	3.66	Issue Type +	En	Location *	
Category	Supplemental			GPS Latitude/Longitude	
				Start	End
Item	DWR UCIP Field Study			38.454154 °	38.454154 °
				-121.502939 °	-121.502939 °
DWR ID					
Comment Code					
Inspector Comment					
FS_ID:16925 DS_ID:21723 EP_NO: 8030 Repair Type: Non-Urgent Crossing Status: Found UCIP Comments: Excessive vegetation should be cleared from conduit and JP on LS toe. FIELD_STRUCT_DESC: 2 of 2: 1.5-inch electrical conduit of an unknown material through the levee, 6 feet below the crown. Walkway on the waterside (WS) slope to pump on a pile structure. Meter on joint pole (JP) at the landside (LS) toe. (Permit No. 8030, 1972 - Robert and Hazel Kirkland). [Additional Reference(s): DWR Levee Log, 1990]. FS Date: 7/31/2013

Conduit visible on WS slope.

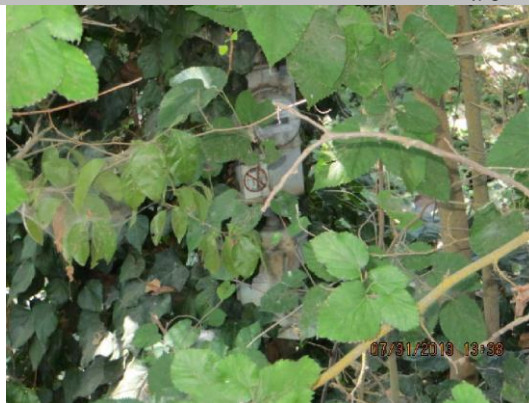
Photo 2 of 2 : UCIP_SP_2018_16925_28983.jpg

LM Start	3.66	Rating **	M	Issue No.	143 (cont)	
LM End	3.66	Issue Type +	En	Location *		
Category	Supplemental			GPS Latitude/Longitude		
				Start	End	
Item	DWR UCIP Field Study			38.454154 °	38.454154 °	
				-121.502939 °	-121.502939 °	
DWR ID						
Comment Code						
Inspector Comment						
FS_ID:16925 DS_ID:21723 EP_NO: 8030 Repair Type: Non-Urgent Crossing Status: Found UCIP Comments: Excessive vegetation should be cleared from conduit and JP on LS toe. FIELD_STRUCT_DESC: 2 of 2: 1.5-inch electrical conduit of an unknown material through the levee, 6 feet below the crown. Walkway on the waterside (WS) slope to pump on a pile structure. Meter on joint pole (JP) at the landside (LS) toe. (Permit No. 8030, 1972 - Robert and Hazel Kirkland). [Additional Reference(s): DWR Levee Log, 1990]. FS Date: 7/31/2013

JP and meter on LS toe.

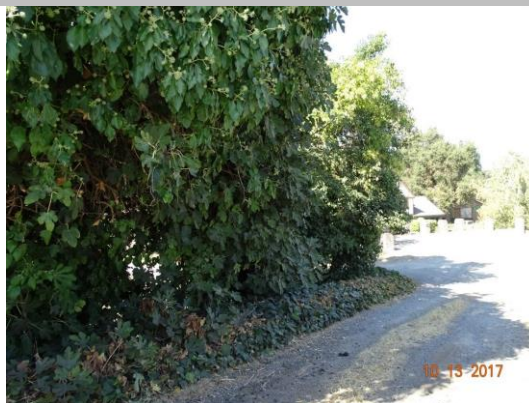
Photo 1 of 1 : SP_2018_RD0307_166_109_20180301_00054.jpg

LM Start	3.86	Rating **	M	Issue No.	109
LM End	3.86	Issue Type +	En	Location *	LS
Category	Earthen Levee			GPS Latitude/Longitude	
				Start	End
Item	Vegetation			38.451239 °	38.451239 °
				-121.502636 °	-121.502636 °
DWR ID	DWR_RD0307_01_f_2017_109				
Comment Code					
V6 : Landscaping					
Inspector Comment					
Trim and thin landscaping to allow inspection and access to landside levee slope and toe.

Trim and thin landscaping to allow inspection and access to landside levee slope and toe.

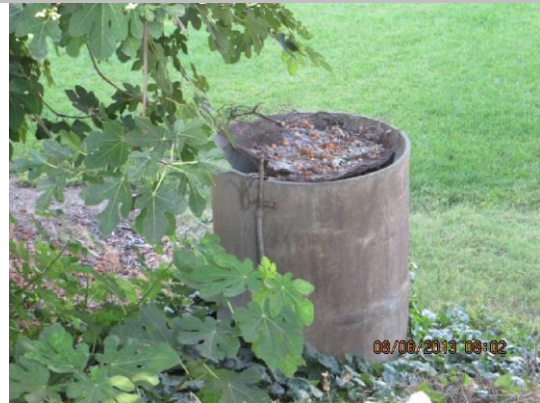
Photo 3 of 3 : UCIP_SP_2018_51445_29020.jpg

Comment Code						
Inspector Comment						
FS_ID:51445 DS_ID:21682 EP_NO: 8034 Repair Type: Urgent Crossing Status: Found UCIP Comments: 12/07/2016 Crossing has been downgraded from Urgent to Non-Urgent pipe appears abandoned. Need to coordinate with owner to determine status of crossing. If crossing is abandoned, owner will need to coordinate with the CVFPB to comply with Title 23. (O. Magana - DWR UCIP)08/06/2013 Appears abandoned and should be done so properly. Walkway to pier is falling apart and is an attractive nuisance. Pipe rusted through at riser on LS toe. (W. Wylie - DWR UCIP) FIELD_STRUCT_DESC: *ABANDONED* 1 of 2: 14-inch steel irrigation pipe through the levee, 13 feet below the crown. Pump on pile structure with walkway located on waterside (WS) slope. Gate valve located on the WS toe and a 48-inch concrete standpipe located on the LS toe. Sheet pile wall around base of metal pier at WS toe (14-inch pipe first referenced in the USACE O&M Manual and later pipe authorized under Automatic Board Order (ABO) issued as Permit No. 8034, 1972 - Heringer). [Additional Reference(s): DWR Levee Log, 1990. USACE Sacramento O&M Manual Unit 114, October 1964 (River Mile 45.67)]. FS Date: 12/7/2016

48-inch concrete standpipe on LS toe.

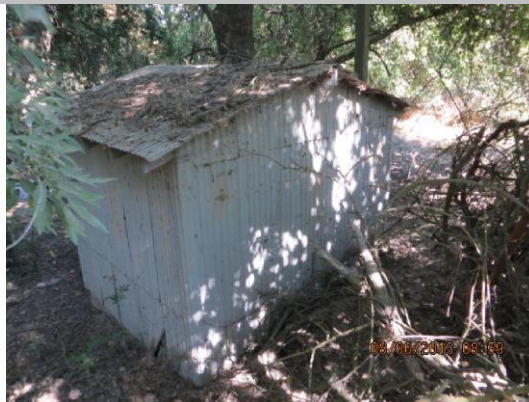
Photo 3 of 3 : UCIP_SP_2018_22670_38292.jpg

Comment Code					
Inspector Comment					
FS_ID:22670 DS_ID:21685 EP_NO: 8039 Repair Type: Non-Urgent Crossing Status: Found UCIP Comments: No lid on CMP riser on WS slope. this could create a hazard for the public. FIELD_STRUCT_DESC: 8-inch steel irrigation pipe through the levee, 12 feet below the crown. Gate valve in a 6-foot-diameter corrugated metal pipe (CMP) riser on the waterside (WS) slope. Pump and gate valve in pump house on the landside (LS) toe. (Permit No. 8039, 1972 - Frederick and Videt Kirtlas and Robert and Hazel Kirtlas). [Additional Reference(s): DWR Levee Log, 1990. USACE Sacramento O&M Manual 114, April 1959, (RM 45.46) (7-inch pipe listed)]. FS Date: 7/31/2013

Pumphouse on LS toe.

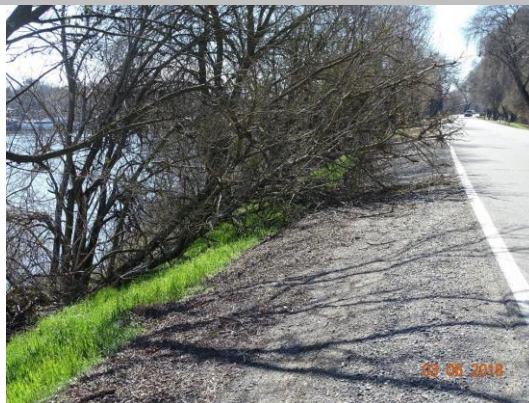
Photo 1 of 1 : SP_2018_RD0307_166_119_20180308_00142.jpg

LM Start	4.11	Rating **	U	Issue No.	119
LM End	4.11	Issue Type +	Ma	Location *	WS
Category	Earthen Levee			GPS Latitude/Longitude	
				Start	End
Item	Encroachments			38.447538 °	38.447538 °
				-121.502659 °	-121.502659 °
DWR ID	DWR_RD0307_01_s_2018_119				
Comment Code					
TR : Tree or limb					
Inspector Comment					
Downed tree on waterside slope.

Downed tree waterside looking south.

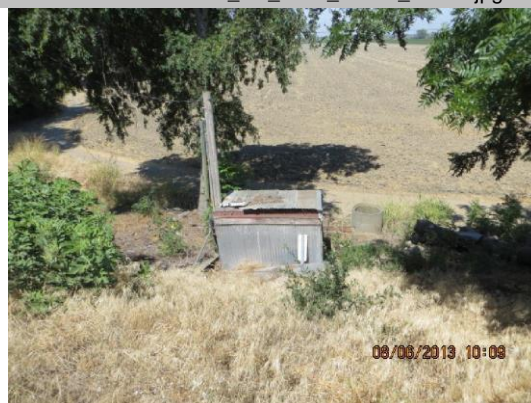
Photo 1 of 3 : UCIP_SP_2018_17183_29321.jpg

Pumphouse for 6-inch pipe at LS toe.

Comment Code						
Inspector Comment						
FS_ID:17183 DS_ID:21690 EP_NO: 8041 Repair Type: Non-Urgent Crossing Status: Found UCIP Comments: Pipe appears abandoned and should be done so properly. Gate valve has been removed from pipe on LS toe. FIELD_STRUCT_DESC: 6-inch steel irrigation pipe through the levee, 13.5 feet below the crown. Pump and gate valve in pump house on the landside (LS) slope. Gate valve on the waterside (WS) slope. Service pole and anchor on the LS slope. (Permit No. 8041, 1972 - Albert and Genevieve Fonts). [Additional Reference(s): DWR Levee Log, 1990. USACE Sacramento O&M Manual 114, April 1959, (RM 45.11)]. FS Date: 8/6/2013

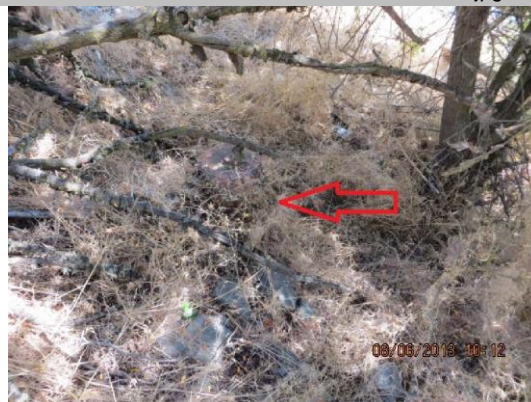
Photo 2 of 3 : UCIP_SP_2018_17183_29320.jpg

Gate valve on WS slope.

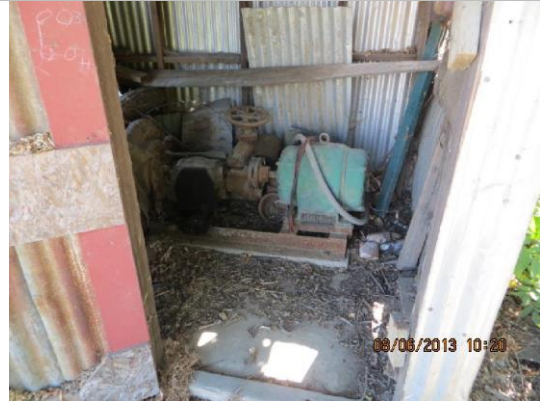
Photo 3 of 3 : UCIP_SP_2018_17183_29323.jpg

Pump in pumphouse on LS toe.

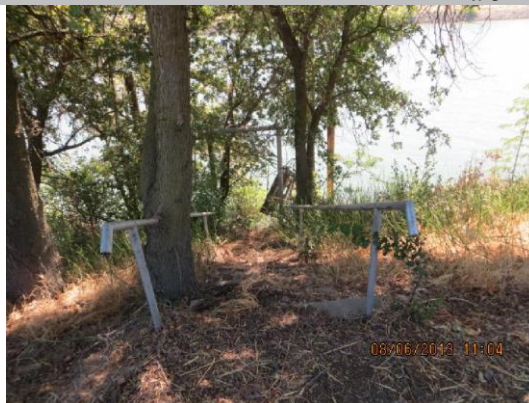
Photo 1 of 3 : UCIP_SP_2018_17184_29326.jpg

LM Start	4.58	Rating **	M	Issue No.	150
LM End	4.58	Issue Type +	En	Location *	
Category	Supplemental			GPS Latitude/Longitude	
				Start	End
Item	DWR UCIP Field Study			38.440915 °	38.440915 °
				-121.504524 °	-121.504524 °
DWR ID					
Comment Code					
Inspector Comment					
FS_ID:17184 DS_ID:21691 EP_NO: 8561 Repair Type: Non-Urgent Crossing Status: Found UCIP Comments: Pipe abandoned and should be done so properly. Gate valve on LS toe broken. FIELD_STRUCT_DESC: 10-inch steel irrigation pipe through the levee, 12.8 feet below the crown. Pump, gate valve, and a 6-foot by 8-foot concrete distribution box on the landside (LS) toe. Gate valve on the waterside (WS) slope. (Permit No. 8561, 1973 - Joseph Borgas). [Additional Reference(s): DWR Levee Log, 1990. USACE Sacramento O&M Manual 114, April 1959, (RM 44.99)]. FS Date: 8/6/2013

Pipe and gate valve on WS slope just downstream from stairs.

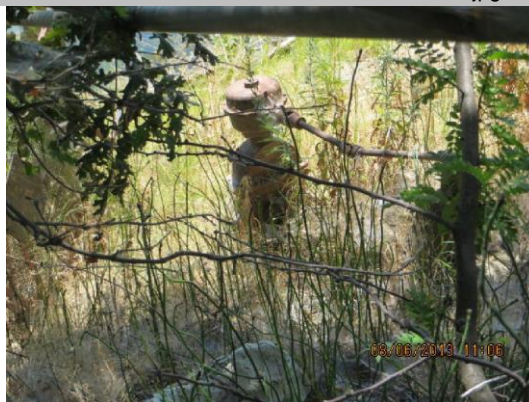
Photo 2 of 3 : UCIP_SP_2018_17184_29325.jpg

Gate valve on WS slope.

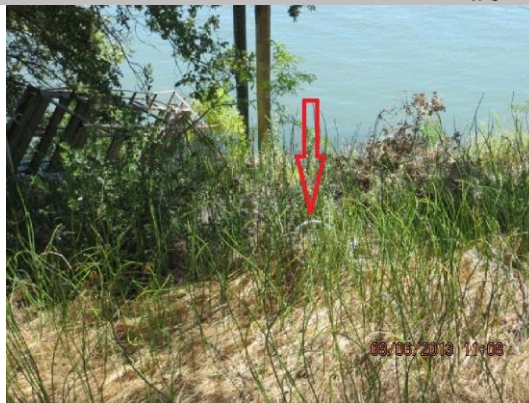
Photo 3 of 3 : UCIP_SP_2018_17184_29324.jpg

Comment Code						
Inspector Comment						
FS_ID:17184						
DS_ID:21691						
EP_NO: 8561						
Repair Type: Non-Urgent						
Crossing Status: Found						
UCIP Comments: Pipe abandoned and should be done so properly.						
Gate valve on LS toe broken.						
FIELD_STRUCT_DESC: 10-inch steel irrigation pipe through the levee,

Gate valve actuator on WS slope.

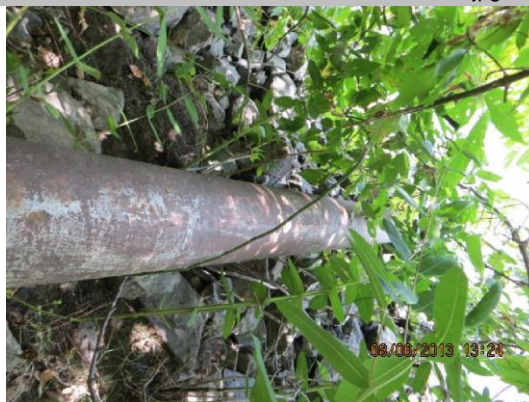
Photo 2 of 3 : UCIP_SP_2018_22710_38414.jpg

Pipe visible on WS slope.

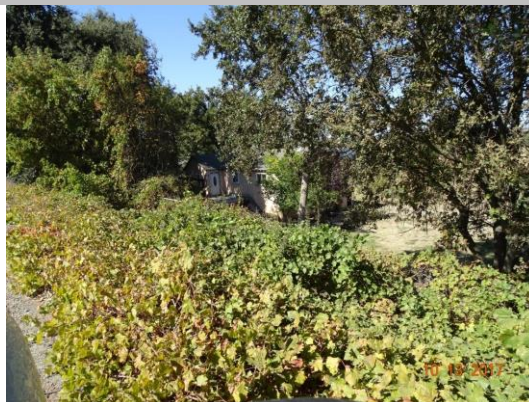
Photo 1 of 1 : SP_2018_RD0307_166_121_20180301_00055.jpg

LM Start	5.23	Rating **	U	Issue No.	121
LM End	5.28	Issue Type +	En	Location *	LS
Category	Earthen Levee			GPS Latitude/Longitude	
				Start	End
Item	Vegetation			38.435926 °	38.435788 °
				-121.514241 °	-121.515092 °
DWR ID	DWR_RD0307_01_f_2017_121				
Comment Code					
V6 : Landscaping					
Inspector Comment

Trim and thin landscaping to allow inspection and access to landside levee slope and toe.

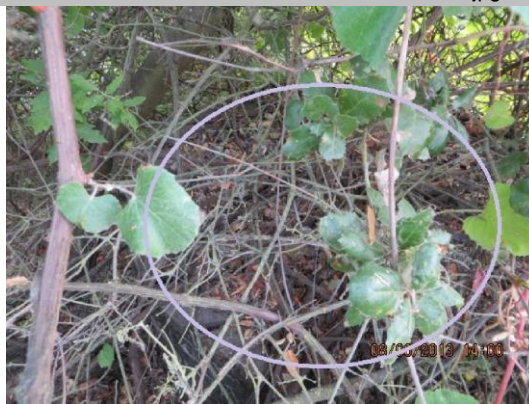
Photo 2 of 2 : UCIP_SP_2018_40546_29420.jpg

Gate valve in 5-foot diameter CMP riser on WS slope.

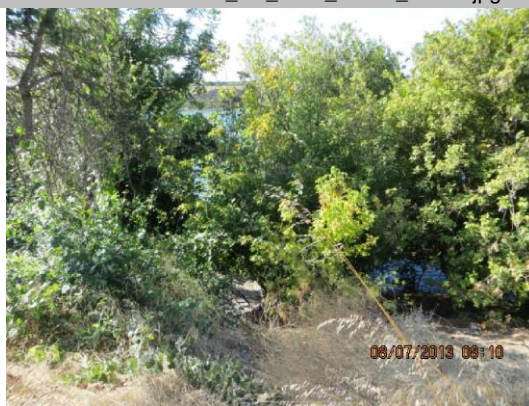
Photo 2 of 3 : UCIP_SP_2018_17287_29422.jpg

Comment Code						
Inspector Comment						
FS_ID:17287 DS_ID:21701 EP_NO: 8050 Repair Type: Non-Urgent Crossing Status: Found UCIP Comments: Lid damaged on 5ft diameter riser on WS slope. Good candidate for video inspection as repair to pipe on LS toe is good indicator that pipe is failing internally. FIELD_STRUCT_DESC: 8-inch steel irrigation pipe through the levee, 12.7 feet below the crown. Pump, vent, butterfly valve, 36-inch concrete standpipe, and a power pole at the landside (LS) toe. Gate valve in a 5-foot-diameter corrugated metal pipe (CMP) riser on the waterside (WS) slope. (Permit No. 8050, 1972 - Glen Franklin Rose). [Additional Reference(s): DWR Levee Log, 1990. USACE Sacramento O&M Manual 114, April 1959, (RM 44.08)]. FS Date: 8/7/2013

Gate valve in 5-foot diameter CMP riser on WS slope.

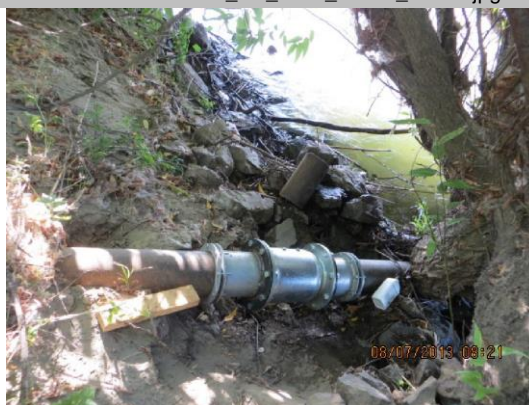
Photo 3 of 3 : UCIP_SP_2018_17287_29425.jpg

Pipe visible at WS toe.

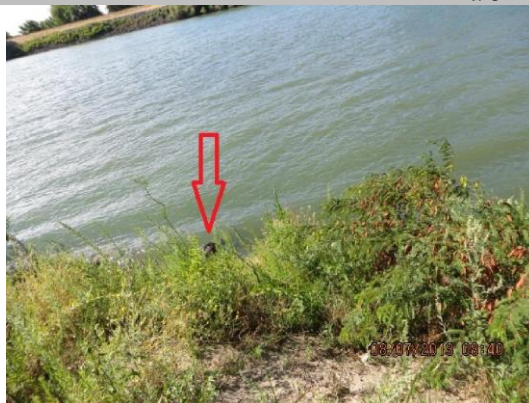
Photo 1 of 3 : UCIP_SP_2018_17343_29442.jpg

Comment Code					
Inspector Comment					
FS_ID:17343 DS_ID:21702 EP_NO: 8051 Repair Type: Non-Urgent Crossing Status: Found UCIP Comments: Annular space between pipes does not appear to be grouted. FIELD_STRUCT_DESC: 10-inch steel irrigation pipe through the levee, 16.8 feet below the crown. 8-inch steel irrigation pipe sleeved through the 10-inch pipe. Pump, vent, power pole, and gate valve on the landside (LS) toe. 36-inch concrete standpipe next to pump on the LS toe. (Permit No. 8051, 1972 - Robert and Hazel Kirtlan and Frederick and Violet Kirtlan). [Additional Reference(s): DWR Levee Log, 1990. USACE Sacramento O&M Manual 114, April 1959, (RM 43.87)]. FS Date: 8/7/2013

Pipe visible on WS toe.

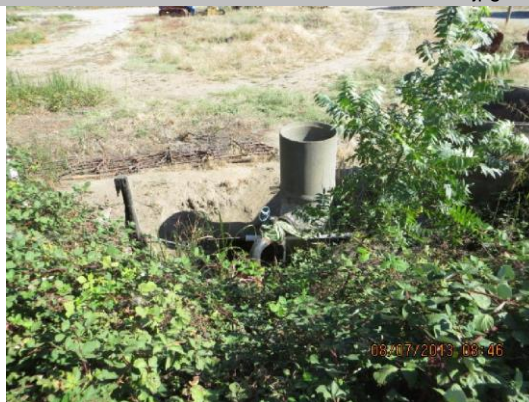
Photo 2 of 3 : UCIP_SP_2018_17343_29441.jpg

Pump, butterfly valve, vent, and concrete standpipe on LS toe.

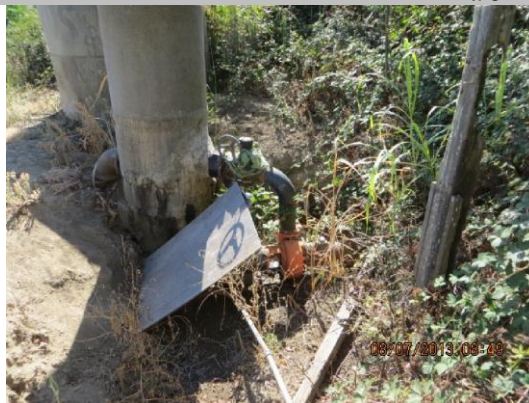
Photo 3 of 3 : UCIP_SP_2018_17343_29440.jpg

Comment Code						
Inspector Comment						
FS_ID:17343 DS_ID:21702 EP_NO: 8051 Repair Type: Non-Urgent Crossing Status: Found UCIP Comments: Annular space between pipes does not appear to be grouted. FIELD_STRUCT_DESC: 10-inch steel irrigation pipe through the levee, 16.8 feet below the crown. 8-inch steel irrigation pipe sleeved through the 10-inch pipe. Pump, vent, power pole, and gate valve on the landside (LS) toe. 36-inch concrete standpipe next to pump on the LS toe. (Permit No. 8051, 1972 - Robert and Hazel Kirtlan and Frederick and Violet Kirtlan). [Additional Reference(s): DWR Levee Log, 1990. USACE Sacramento O&M Manual 114, April 1959, (RM 43.87)]. FS Date: 8/7/2013

Pump, butterfly valve, vent, and concrete standpipe on LS toe. Photo 3 description or comment here.

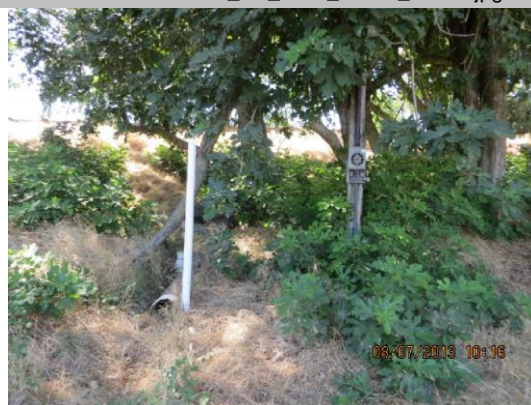
Photo 1 of 2 : UCIP_SP_2018_22711_38419.jpg

LM Start	5.99	Rating **	M	Issue No.	157
LM End	5.99	Issue Type +	En	Location *	
Category	Supplemental			GPS Latitude/Longitude	
				Start	End
Item	DWR UCIP Field Study			38.436038 °	38.436038 °
				-121.528107 °	-121.528107 °
DWR ID					
Comment Code					
Inspector Comment					
FS_ID:22711					
DS_ID:21713					
EP_NO: 6519					
Repair Type: Non-Urgent					
Crossing Status: Found					
UCIP Comments: Appears abandoned and should be done so properly.					
FIELD_STRUCT_DESC: 1.5-inch electrical conduit of an unknown material through the levee, 1 foot below the crown. Slant pump and electrical panel on the waterside (WS) slope, and a power pole and meter on the landside (LS) toe. (Permit No. 6519, 1969 - S. H. Cowell Foundation).					
FS Date: 8/7/2013 10:24:00 AM

Power pole and meter off LS toe.

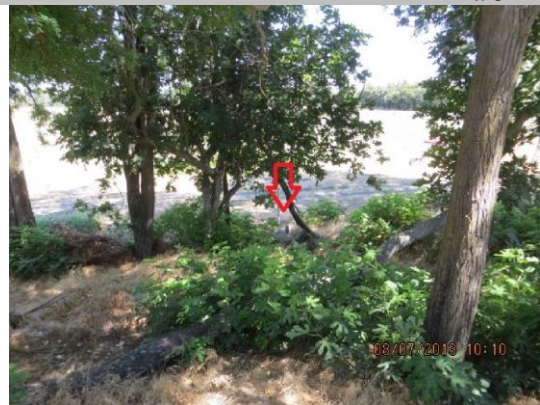
Photo 1 of 3 : UCIP_SP_2018_22712_38422.jpg

Comment Code					
Inspector Comment					
FS_ID:22712 DS_ID:21732 EP_NO: 8053 Repair Type: Non-Urgent Crossing Status: Found UCIP Comments: Annular space between pipes does not appear to be grouted. FIELD_STRUCT_DESC: 20-inch steel irrigation pipe through the levee, 14.7 feet below the crown. 16-inch irrigation pipe sleeved through the 20-inch pipe. Slant pump and gate valve on the waterside (WS) slope. Gate valve, power pole, and electrical panel on the landside (LS) toe. (Permit No. 8053, 1972 - S. H. Cowell Foundation, E. H. Connick, Max Theldan, and W. F. Bank). [Additional Reference(s): DWR Levee Log, 1990. USACE Sacramento O&M Manual 114, April 1959, (RM 43.57)]. FS Date: 8/7/2013

Pipe on LS toe.

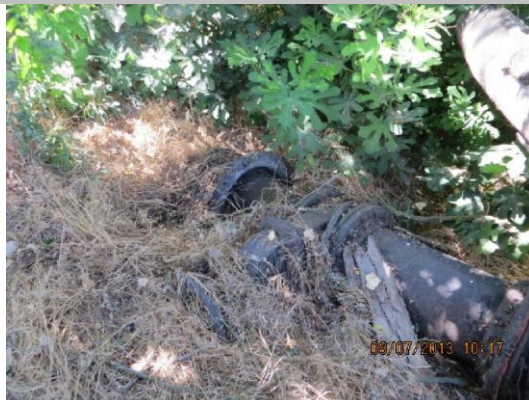
Photo 3 of 3 : UCIP_SP_2018_22712_38420.jpg

Gate valve on LS toe.

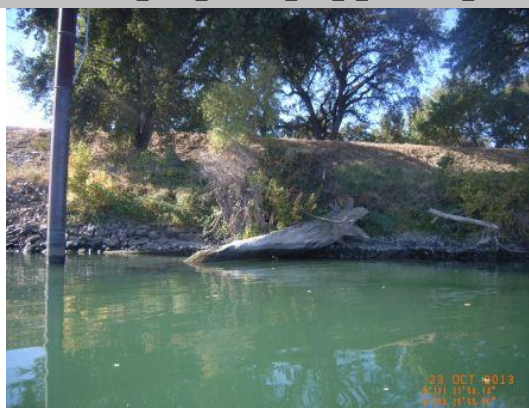
Photo 1 of 1 : SP_2018_RD0307_166_2_20180301_00002.jpg

LM Start	6.19	Rating **	M	Issue No.	2
LM End	6.38	Issue Type +	Ma	Location *	WS
Category	Supplemental			GPS Latitude/Longitude	
				Start	End
Item	2015 USACE Erosion Survey, DRAFT			38.434560 °	38.432287 °
				-121.531159 °	-121.532978 °
DWR ID	DWR_RD0307_01_s_2016_2				
Comment Code					
Inspector Comment					
2008 - Large rotational failure in bank and well into the levee slope. Could be a significant problem in the next high flow event. 2009 - Minimal new erosion, site extended upstream. 2010 - Minor new erosion. 2011 - Tree popout has left a large hole. Large slump area. Rock on the bank is failing in some locations. 2012 - The toe appears to be scouring out. 2015: No observed changes. [2015 Site ID: SAC_43-2_R]

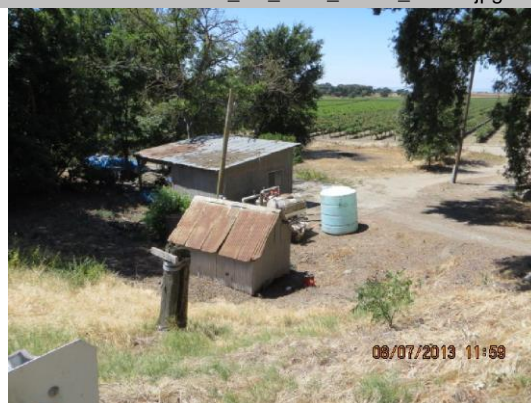
Photo 1 of 3 : UCIP_SP_2018_17385_29489.jpg

LM Start	6.40	Rating **	M	Issue No.	159
LM End	6.40	Issue Type +	En	Location *	
Category	Supplemental			GPS Latitude/Longitude	
				Start	End
Item	DWR UCIP Field Study			38.432040 °	38.432040 °
				-121.533290 °	-121.533290 °
DWR ID					
Comment Code					
Inspector Comment					
FS_ID:17385 DS_ID:21706 EP_NO: 8057 Repair Type: Non-Urgent Crossing Status: Found UCIP Comments: Pipe appears abandoned and should be done so properly. FIELD_STRUCT_DESC: 10-inch steel irrigation pipe through the levee, 13.8 feet below the crown. Pump and gate valve in pump house on the landside (LS) toe. (Permit No. 8057, 1972 - Lawrence R. and Ruth Schneider). [Additional Reference(s): DWR Levee Log, 1990. USACE Sacramento O&M Manual 114, April 1959, (RM 43.14)]. FS Date: 8/7/2013

Pump and gate valve inside pumphouse on LS toe.

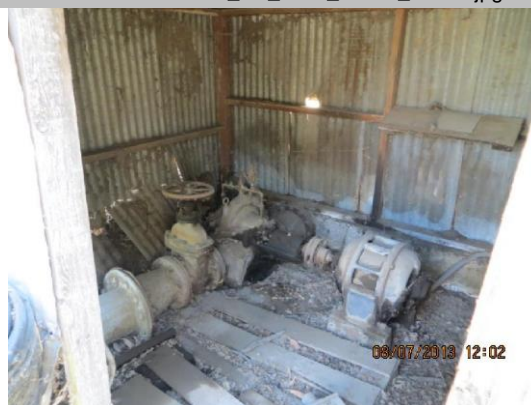
Photo 2 of 3 : UCIP_SP_2018_17385_29488.jpg

Pump and gate valve inside pumphouse on LS toe.

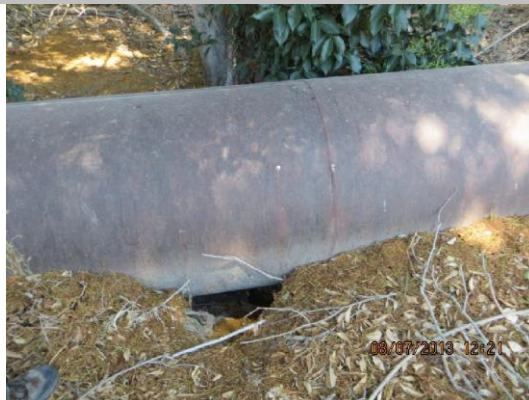
Photo 2 of 3 : UCIP_SP_2018_17404_29503.jpg

Animal activity/burrows under pipe on LS at various locations.
